MEMORANDUM ASBESTOS SURVEY FINAL REPORT CNC CHARLESTON SC
3/1/1998
ENVIRONMENTAL DETACHMENT CHARLESTON

Subj: **ASBESTOS SURVEY FINAL REPORT, Charleston Naval Base Housing**

NAVAL HOUSING CHARLESTON NAVAL BASE CHARLESTON, SOUTH CAROLINA

ASBESTOS INSPECTION REPORT

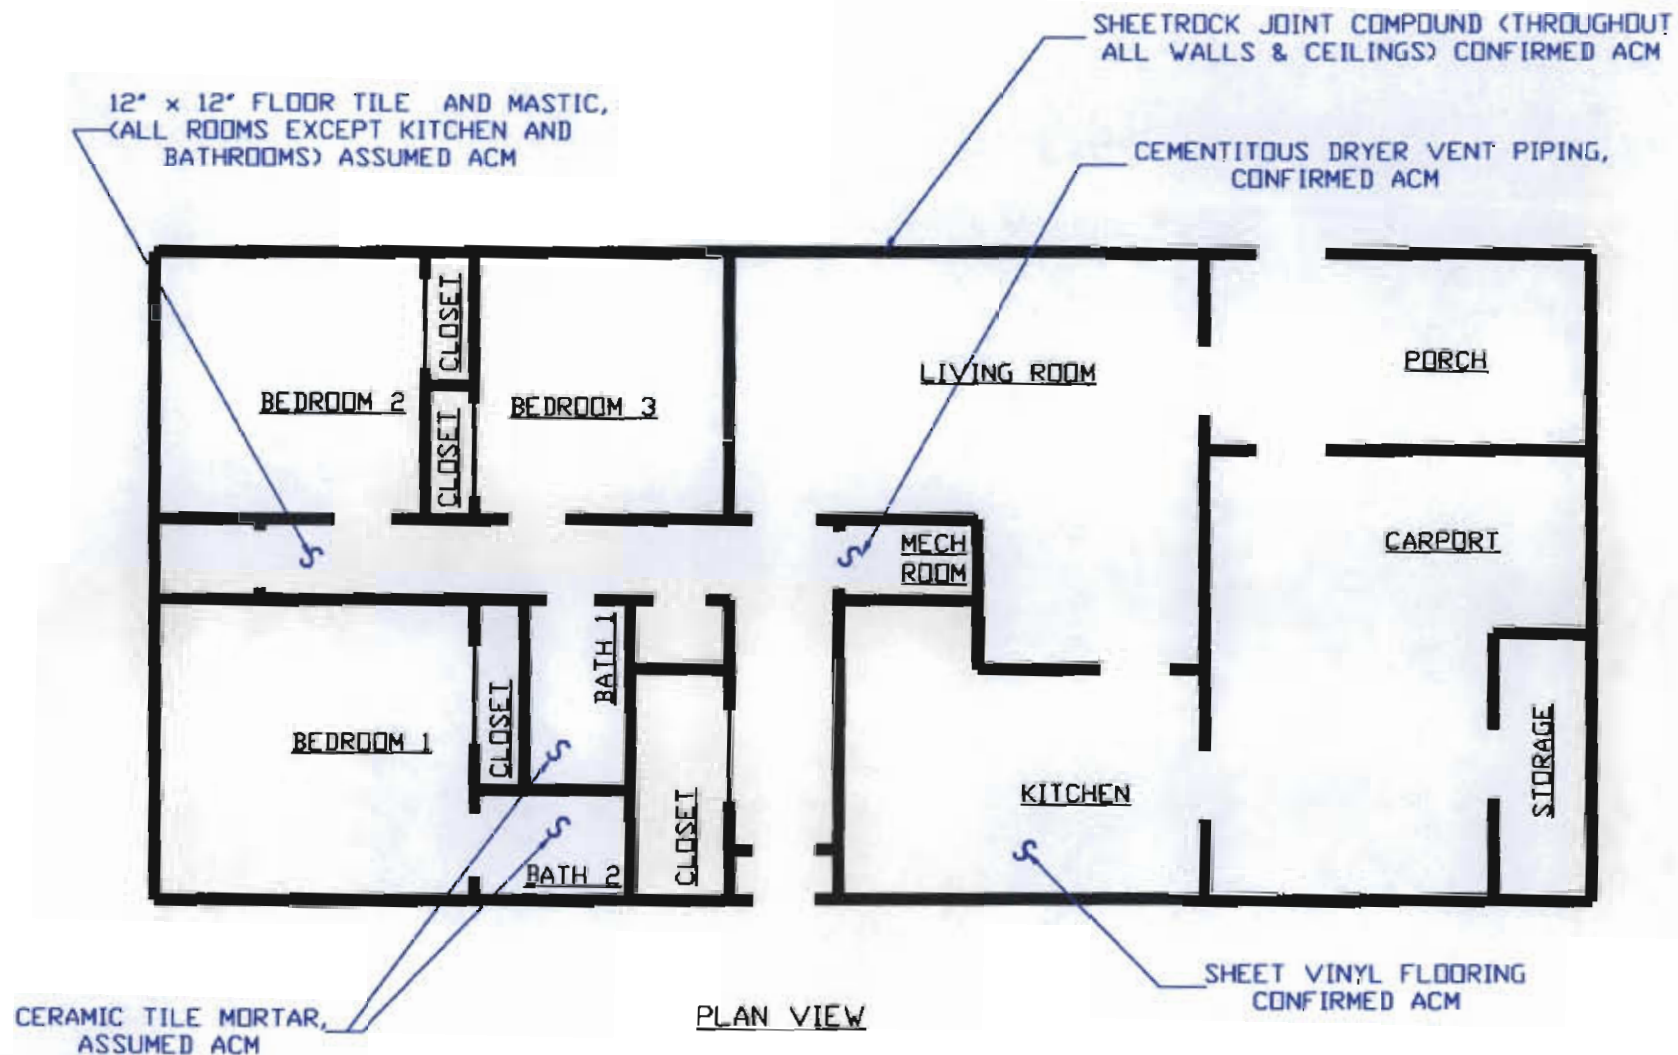
Floor Plan - Type (3J)
 1303 AVENUE "H"
 Charleston Naval Base
 Charleston, SC

Sample No.	ACM Y/N /A	Material Description / LOCATION	Quantity	AHERA CATEGORY	FRIABLE	Cond	% D	Recommended Action	Comments
1409-MANLEY-4	Y	MISC. CEMENTITIOUS PIPING, CLOTHES DRYER VENT, kitchen, mech. room	10 LF	8	N	G	0	O & M	
ASSUMED	A	CERAMIC TILE MORTAR, bathrooms	270 sq. ft.	8	N	G	0	O & M

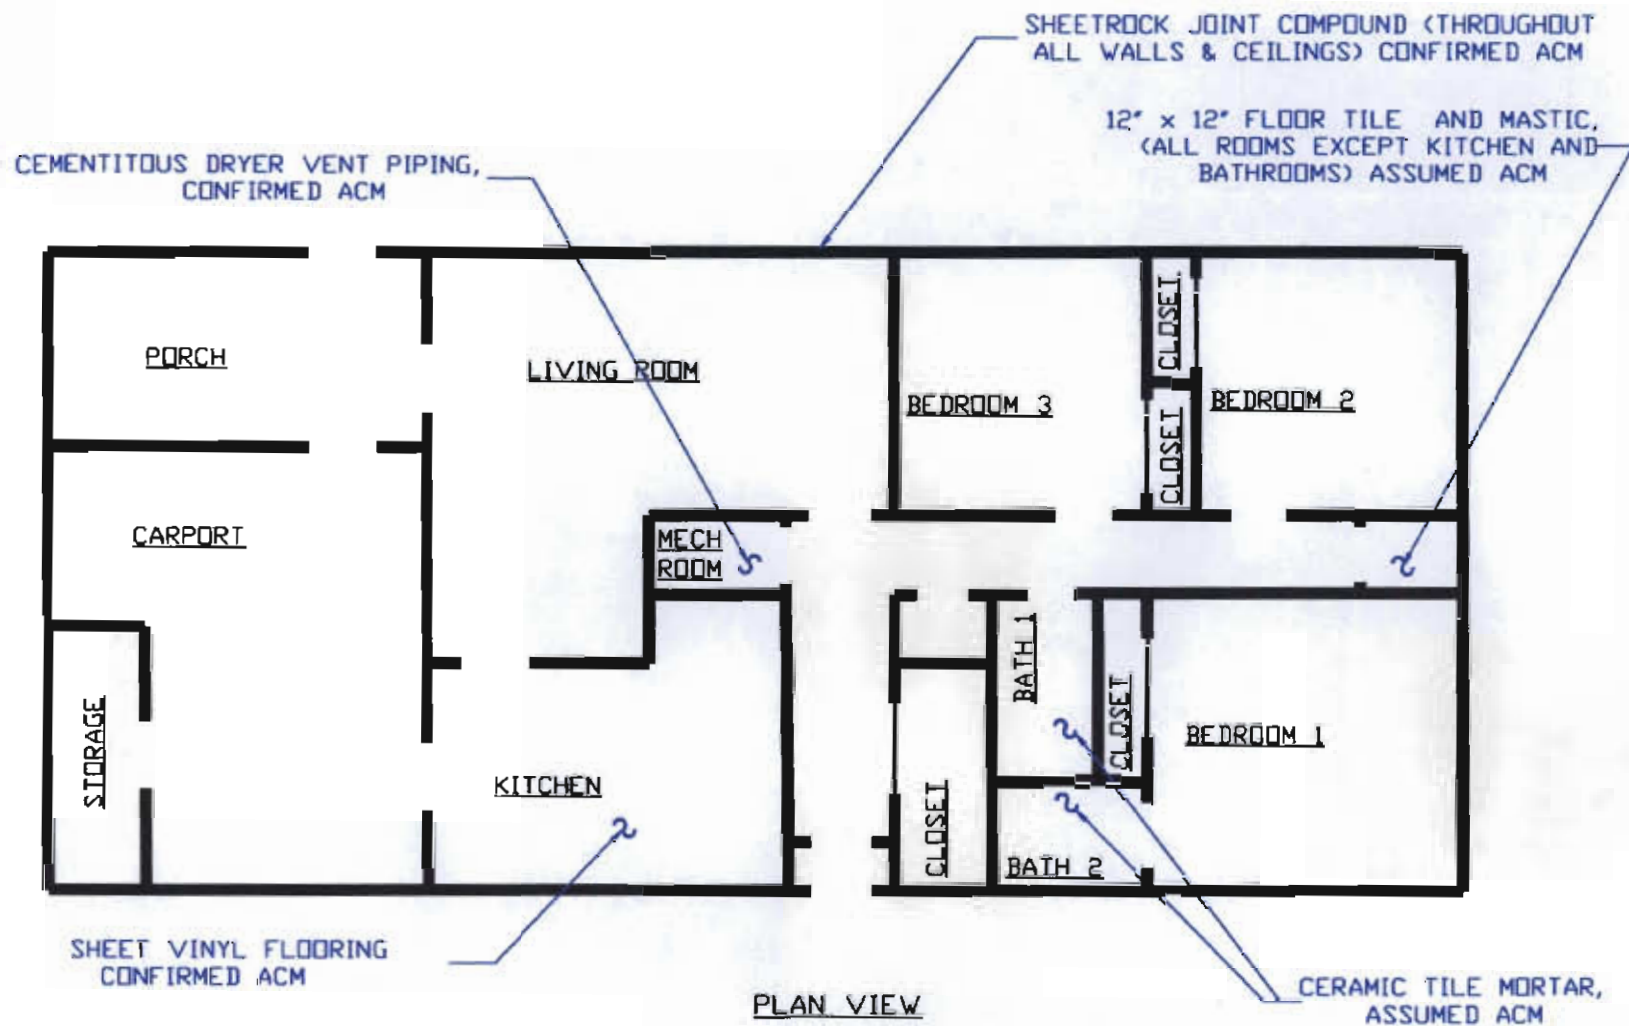
Floor Plan - Type (3J)
1309 AVENUE "H"
Charleston Naval Base
Charleston, SC

Sample No.	ACM Y/N /A	Material Description / LOCATION	Quantity	AHERA CATEGORY	FRIABLE	Cond	% D	Recommended Action	Comments
1409-MANLEY-4	Y	MISC. CEMENTITIOUS PIPING, CLOTHES DRYER VENT, kitchen, mech. room	10 LF	8	N	G	0	O & M	
ASSUMED	A	CERAMIC TILE MORTAR, bathrooms	270 sq. ft.	8	N	G	0	O & M

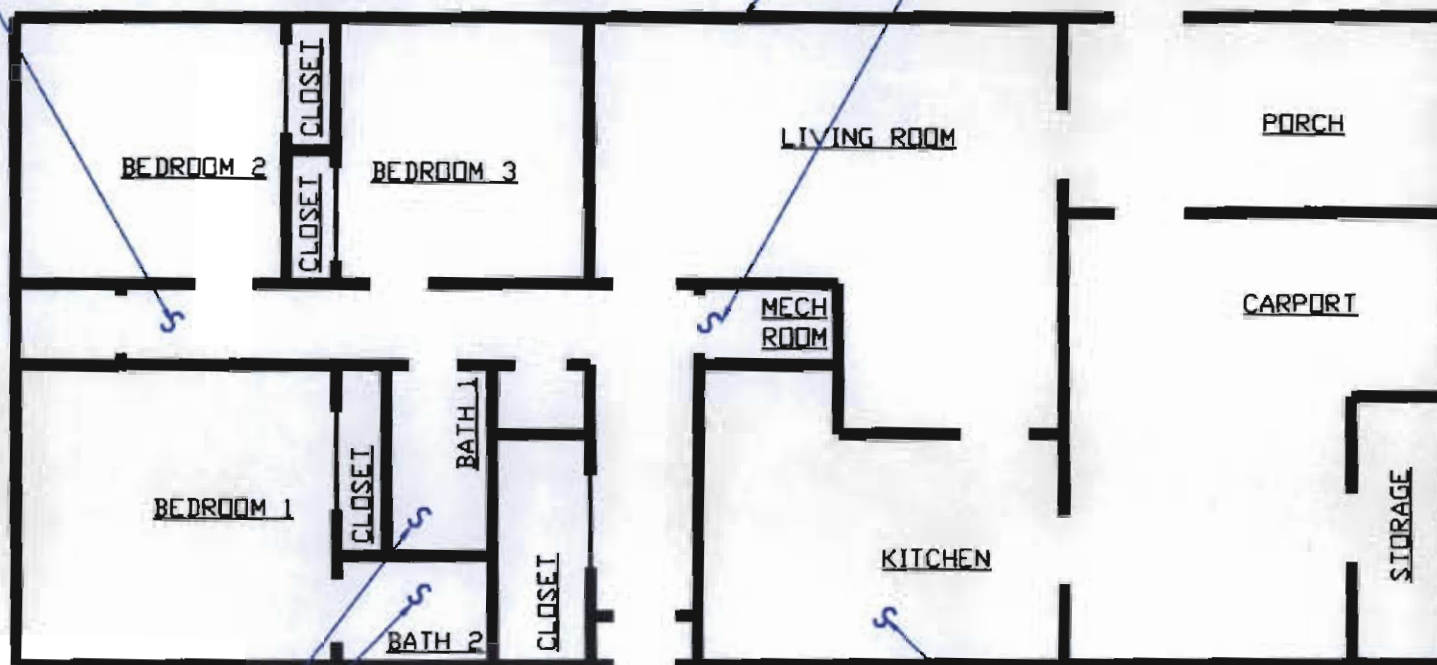
SHEETROCK JOINT COMPOUND (THROUGHOUT
ALL WALLS & CEILINGS) CONFIRMED ACM

CEMENTITIOUS DRYER VENT PIPING,
CONFIRMED ACM

CERAMIC TILE MORTAR,
ASSUMED ACM

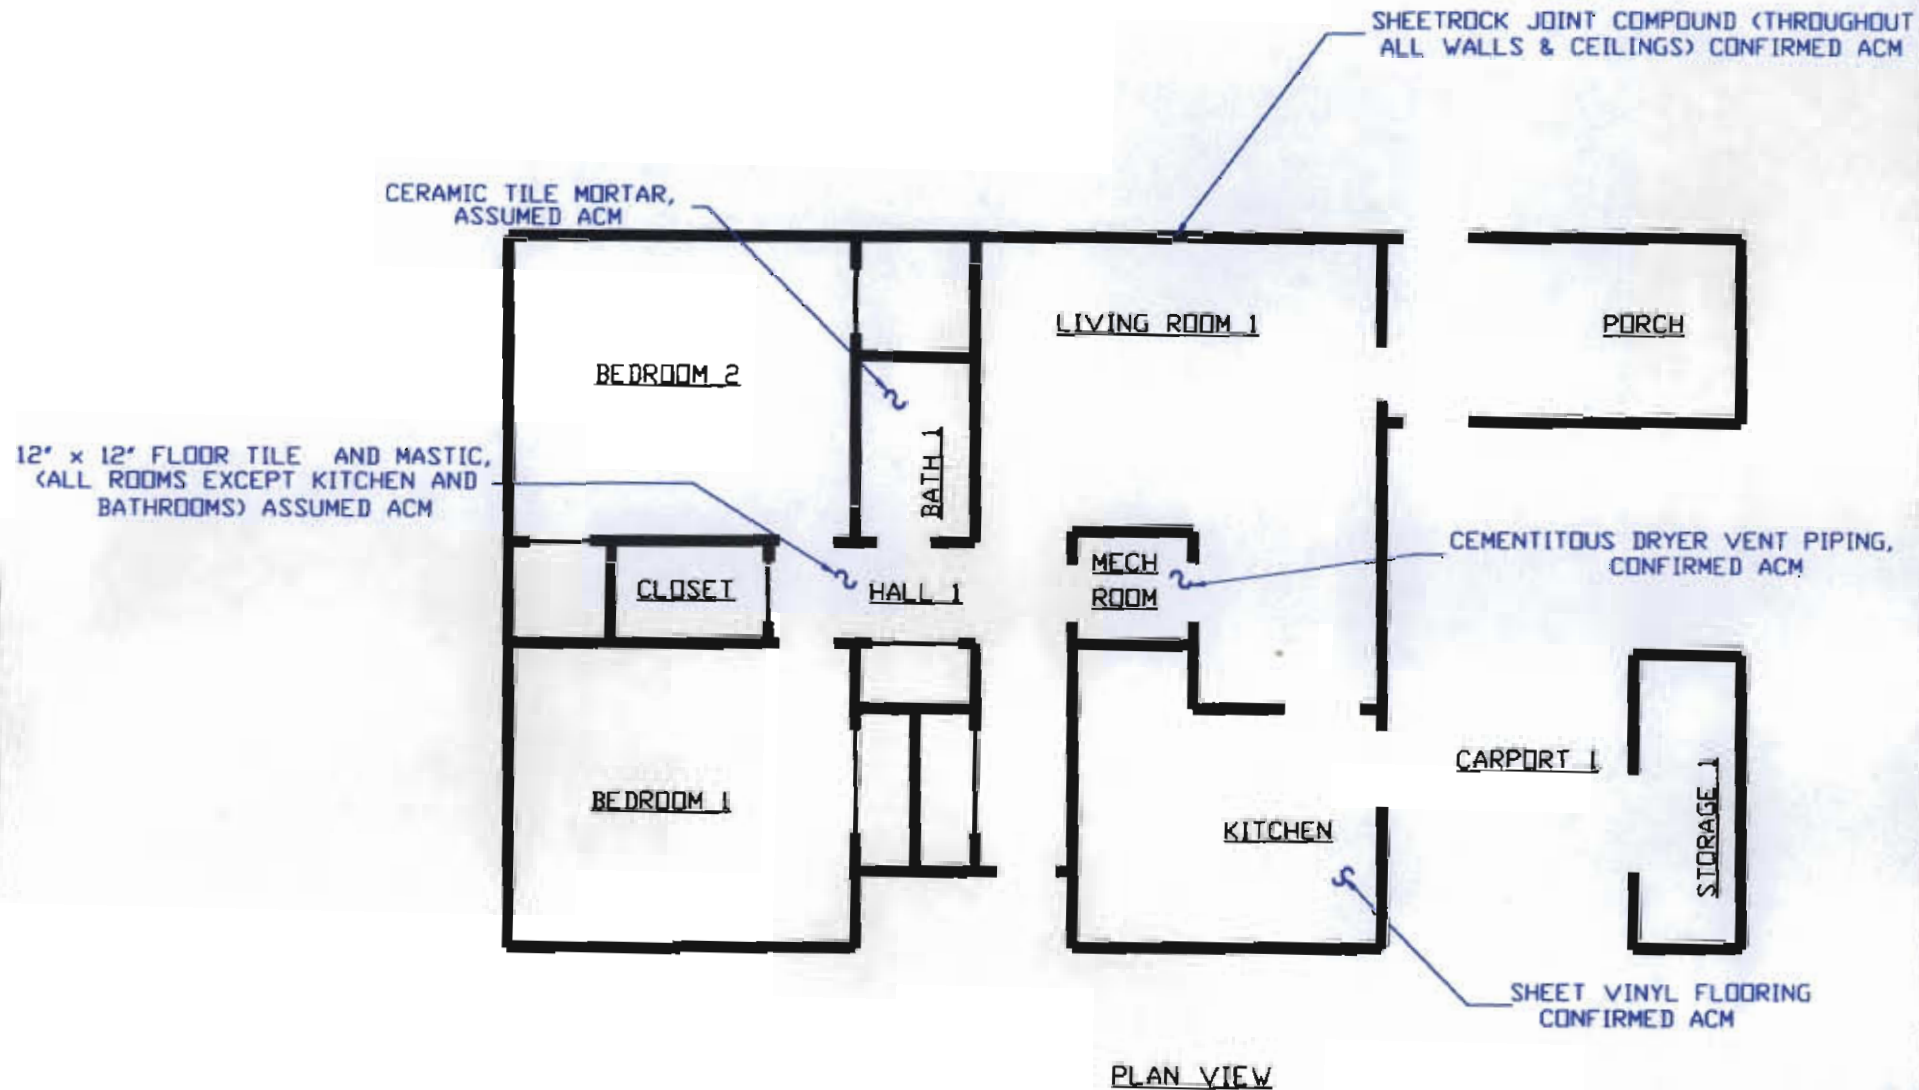
Floor Plan - Type (2J)
1415 MANLEY
Charleston Naval Base
Charleston, SC

Sample No.	ACM Y/N /A	Material Description / LOCATION	Quantity	AHERA CATEGORY	FRIABLE	Cond	% D	Recommended Action	Comments
1409-MANLEY-4	Y	MISC. CEMENTITIOUS PIPING, CLOTHES DRYER VENT, kitchen, mech. room	10 LF	8	N	G	0	O & M	
ASSUMED	A	CERAMIC TILE MORTAR, bathrooms	270 sq. ft.	8	N	G	0	O & M

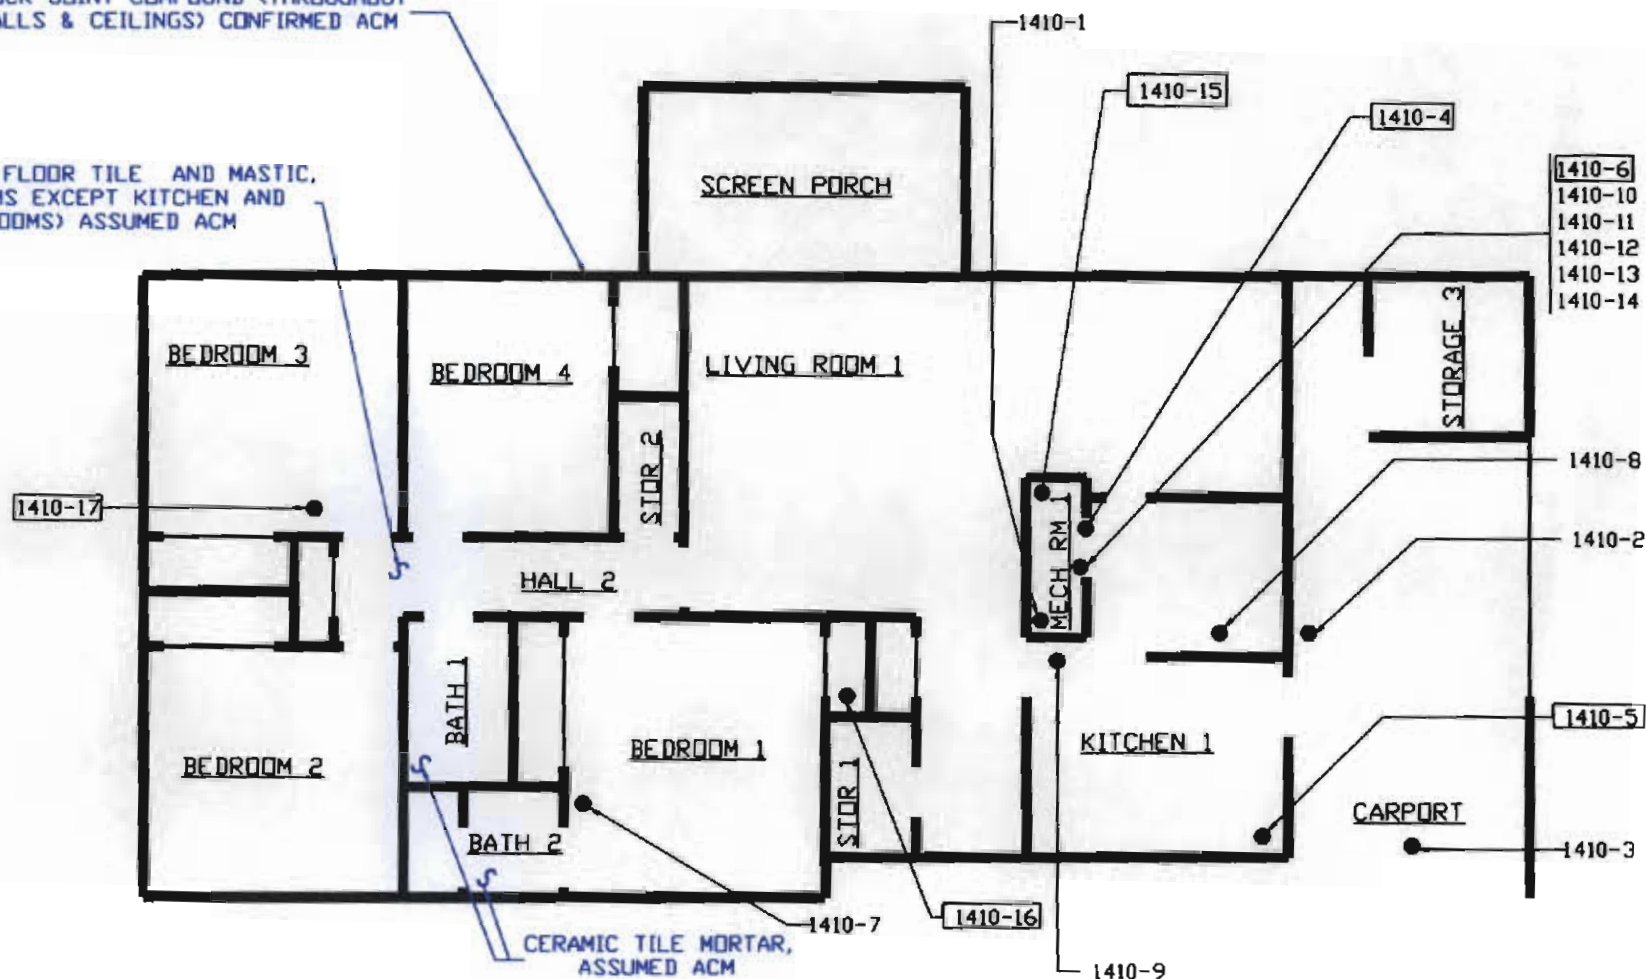
SHEETROCK JOINT COMPOUND (THROUGHOUT ALL WALLS & CEILINGS) CONFIRMED ACM

12" x 12" FLOOR TILE AND MASTIC, (ALL ROOMS EXCEPT KITCHEN AND BATHROOMS) ASSUMED ACM

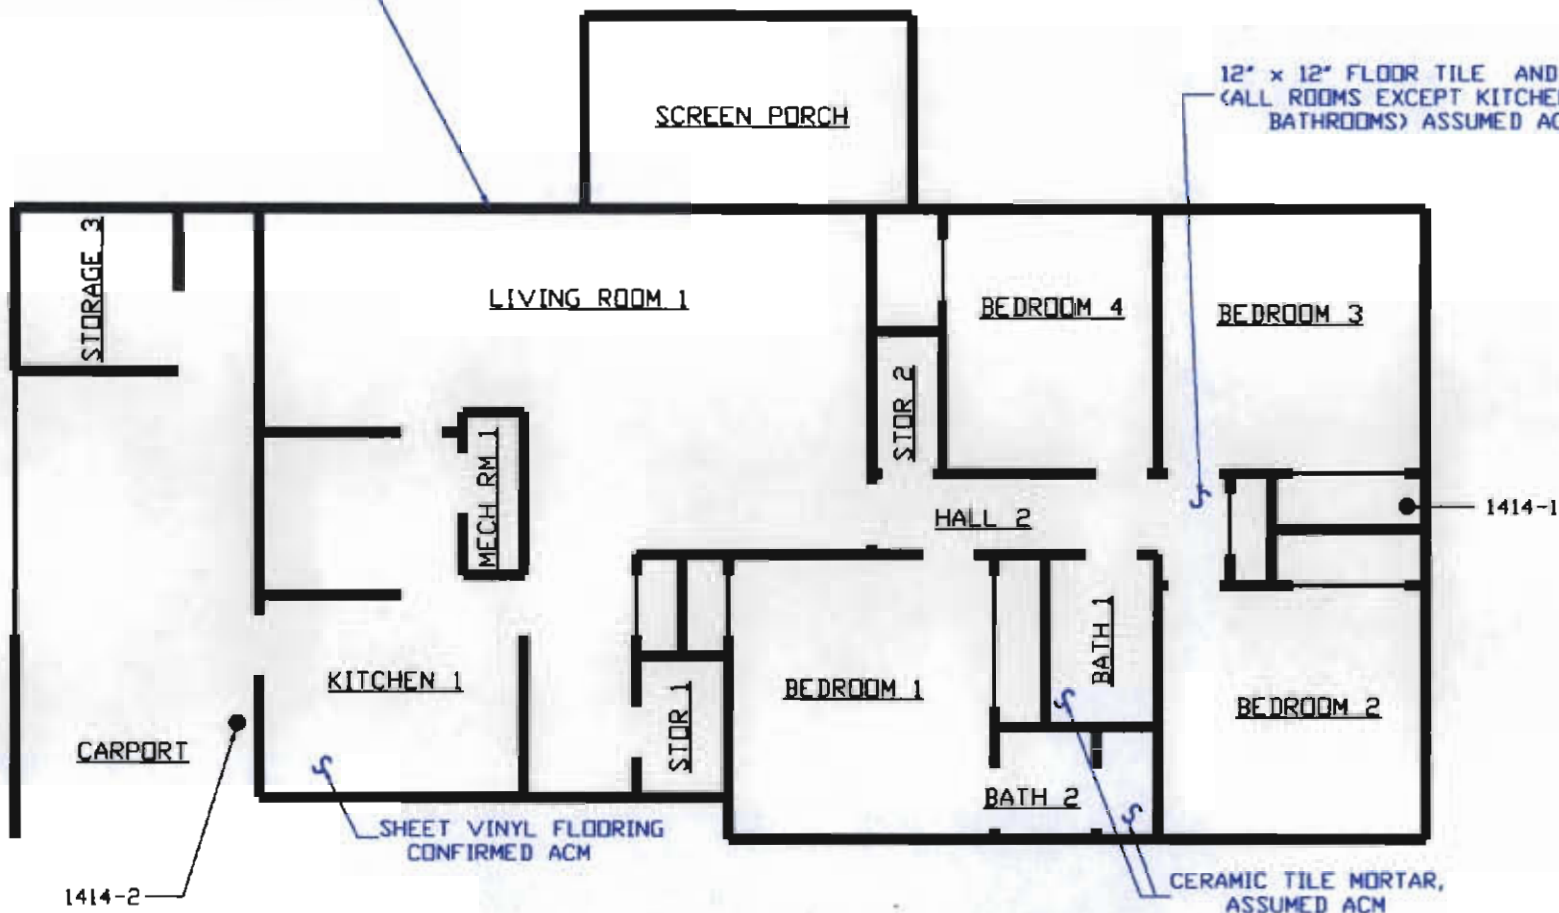
12" x 12" FLOOR TILE AND MASTIC
(ALL ROOMS EXCEPT KITCHEN AND
BATHROOMS) ASSUMED ACM

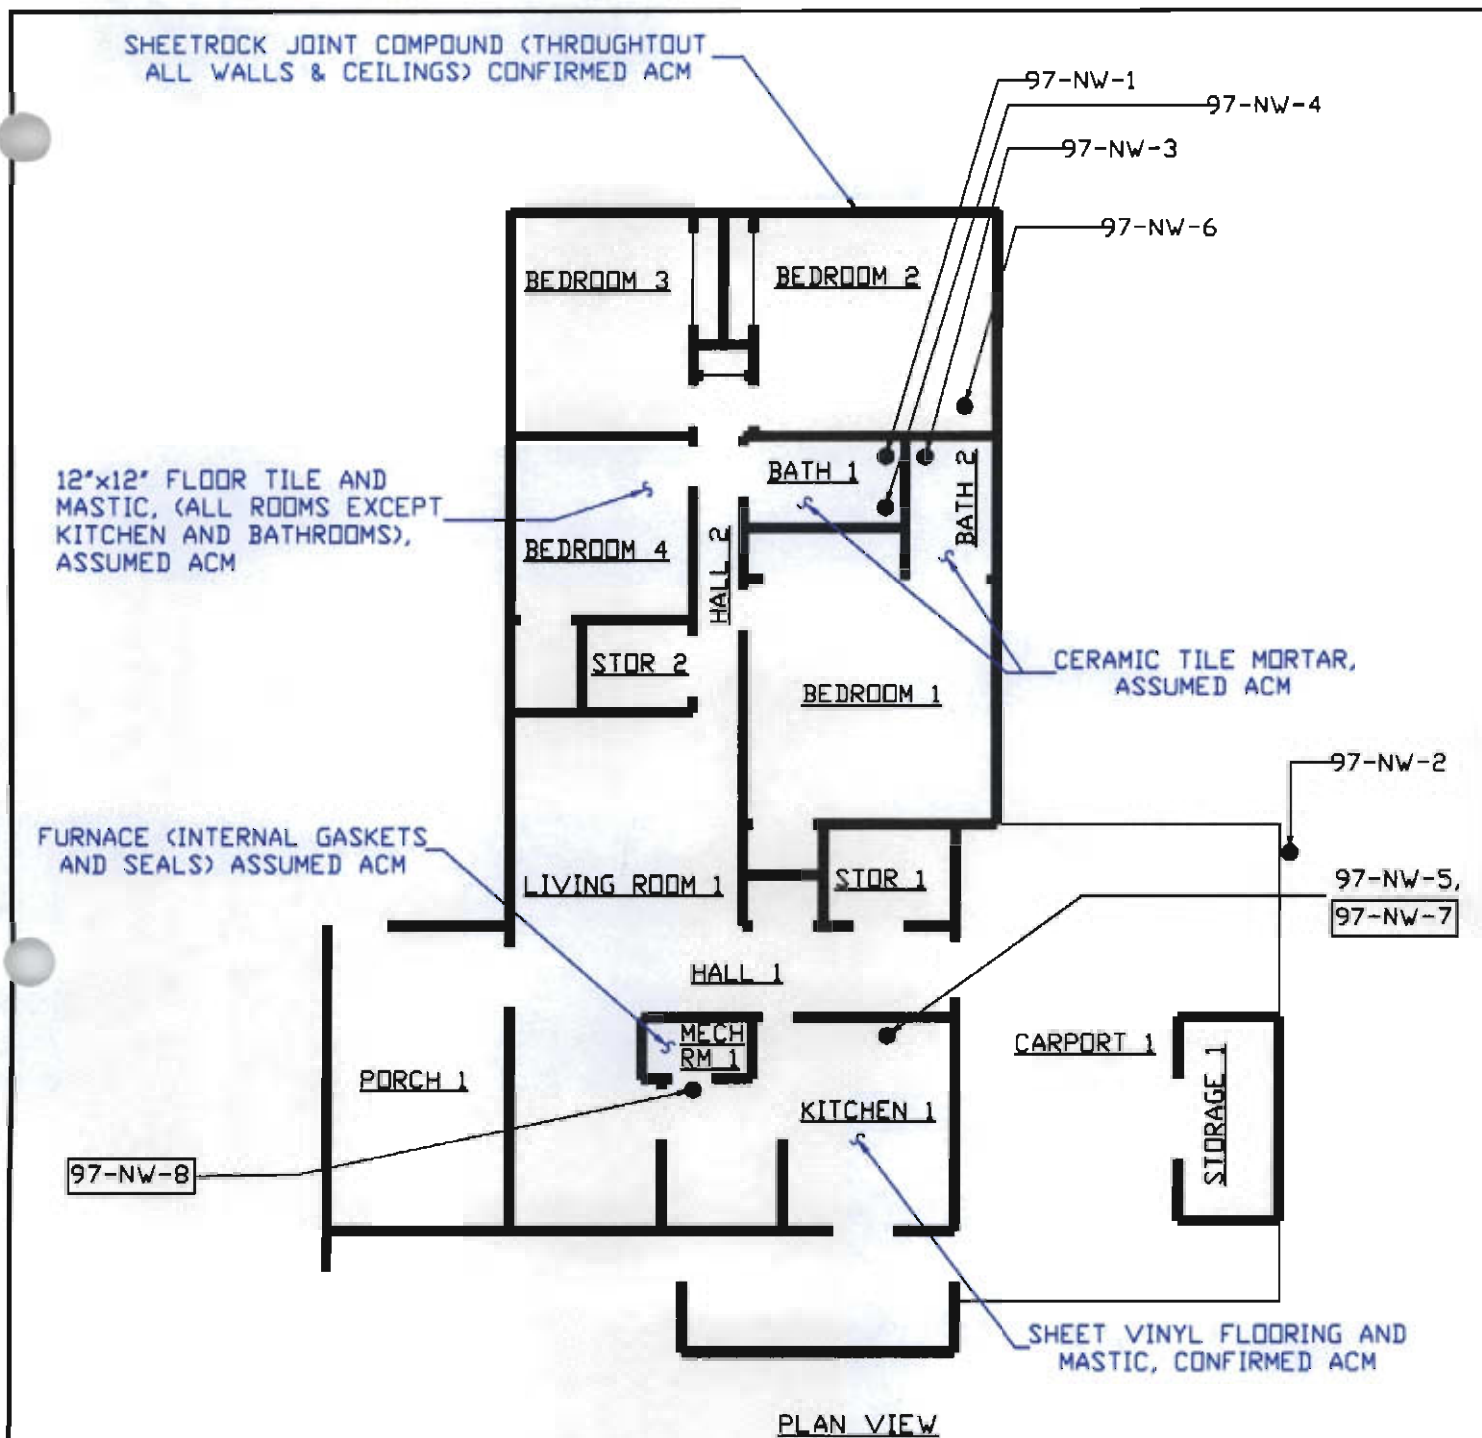
Floor Plan - Type (4S)
190 TURNBULL AVE.
Charleston Naval Base
Charleston, SC

Sample No.	ACM Y/N /A	Material Description / LOCATION	Quantity	AHERA CATEGORY	FRIABLE	Cond	% D	Recommended Action	Comments
190-TURNBULL-1 190-TURNBULL-2 170-TURNBULL-1 170-TURNBULL-2 170-TURNBULL-3	Y N N N Y	MISC. SHEETROCK JOINT COMPOUND	4538 sq. ft.	8	N	G	0	O & M	See General Note 1
ASSUMED	A	MISC., FLOOR TILE and MASTIC, 12" x 12", all rooms except kitchens and bathrooms	1100 sq. ft.	8	N	G	0	O & M	
378-Turnbull-1 378-Turnbull-2 378-Turnbull-3 378-Turnbull-4 97-NW-7 97-NW-8	Y N Y N Y Y	MISC., SHEET VINYL FLOORING and MASTIC, kitchens	176 sq. ft.	8	N	G	2	O & M	3 sq. ft. damaged in kitchen at range location Also, there are multiple layers of sheet vinyl flooring.
ASSUMED	A	TSI, FURNACE							See General Note 3
ASSUMED	A	MISC., CERAMIC TILE MORTAR	284 sq. ft.	8	N	G	0	O & M

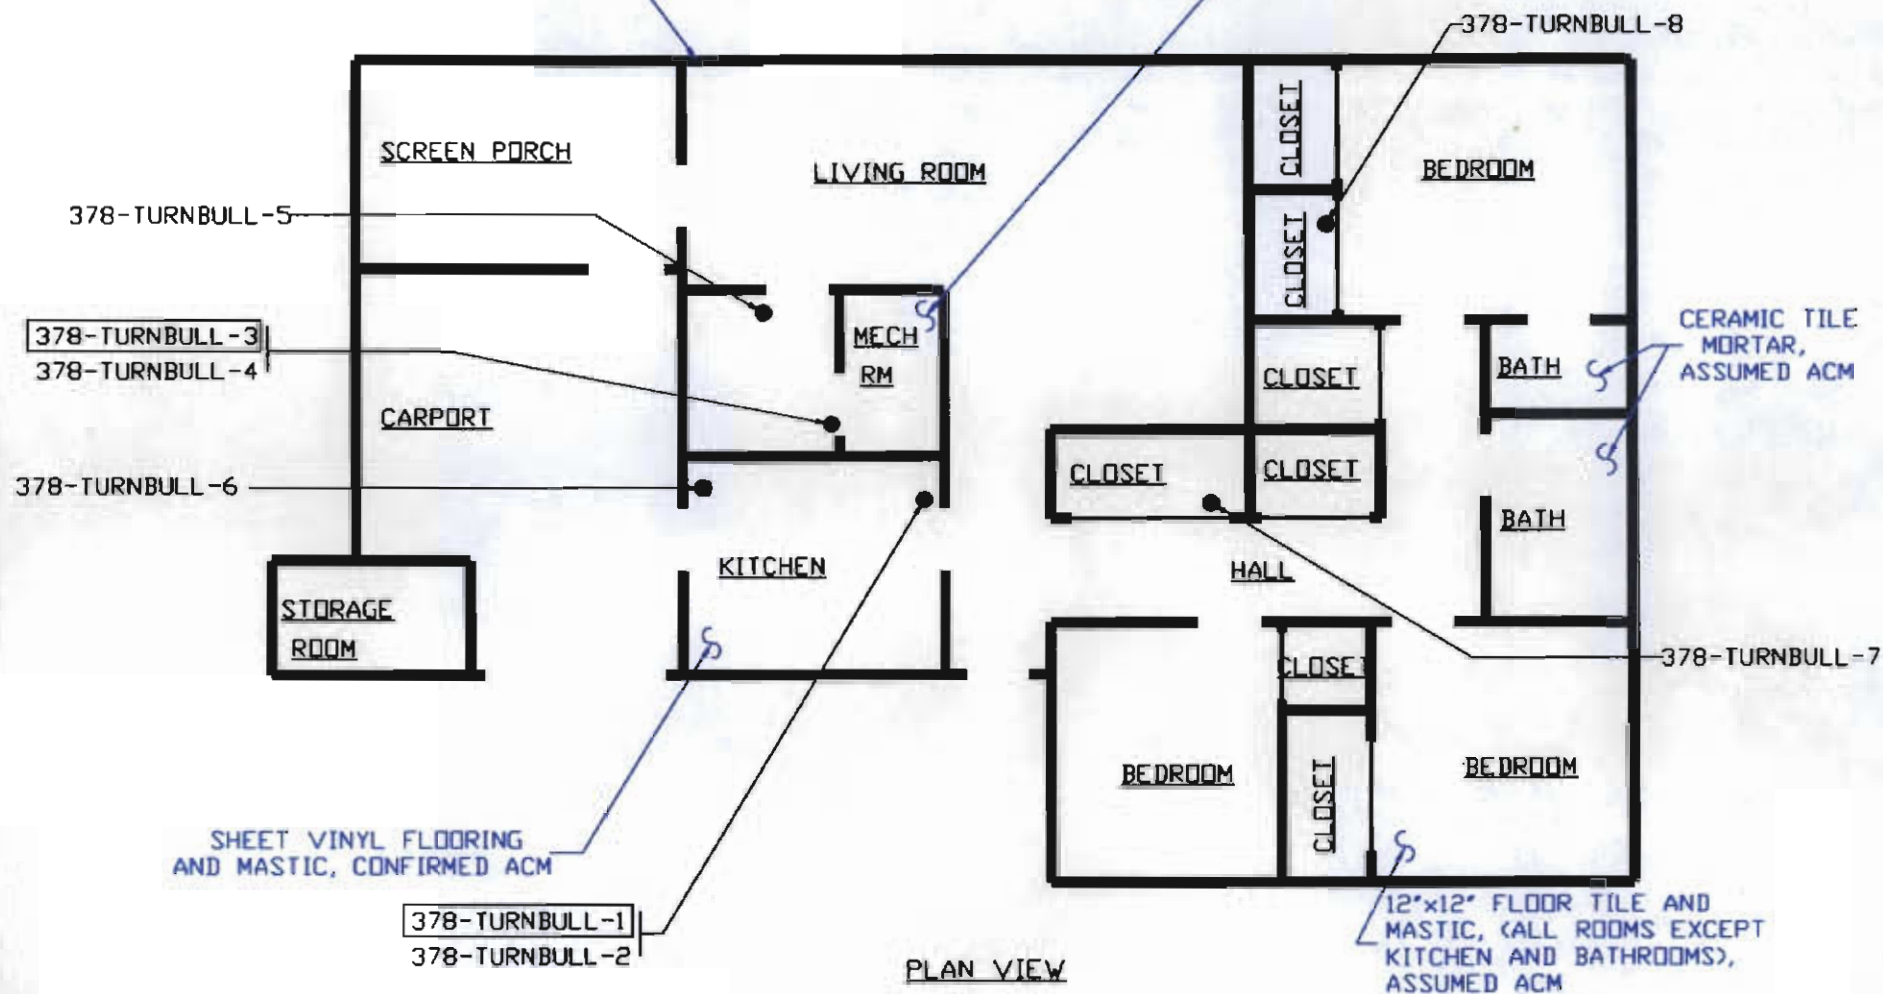
SHEETROCK JOINT COMPOUND (THROUGHOUT ALL WALLS & CEILINGS) CONFIRMED ACM

FURANCE (INTERNAL GASKETS AND SEALS) ASSUMED ACM

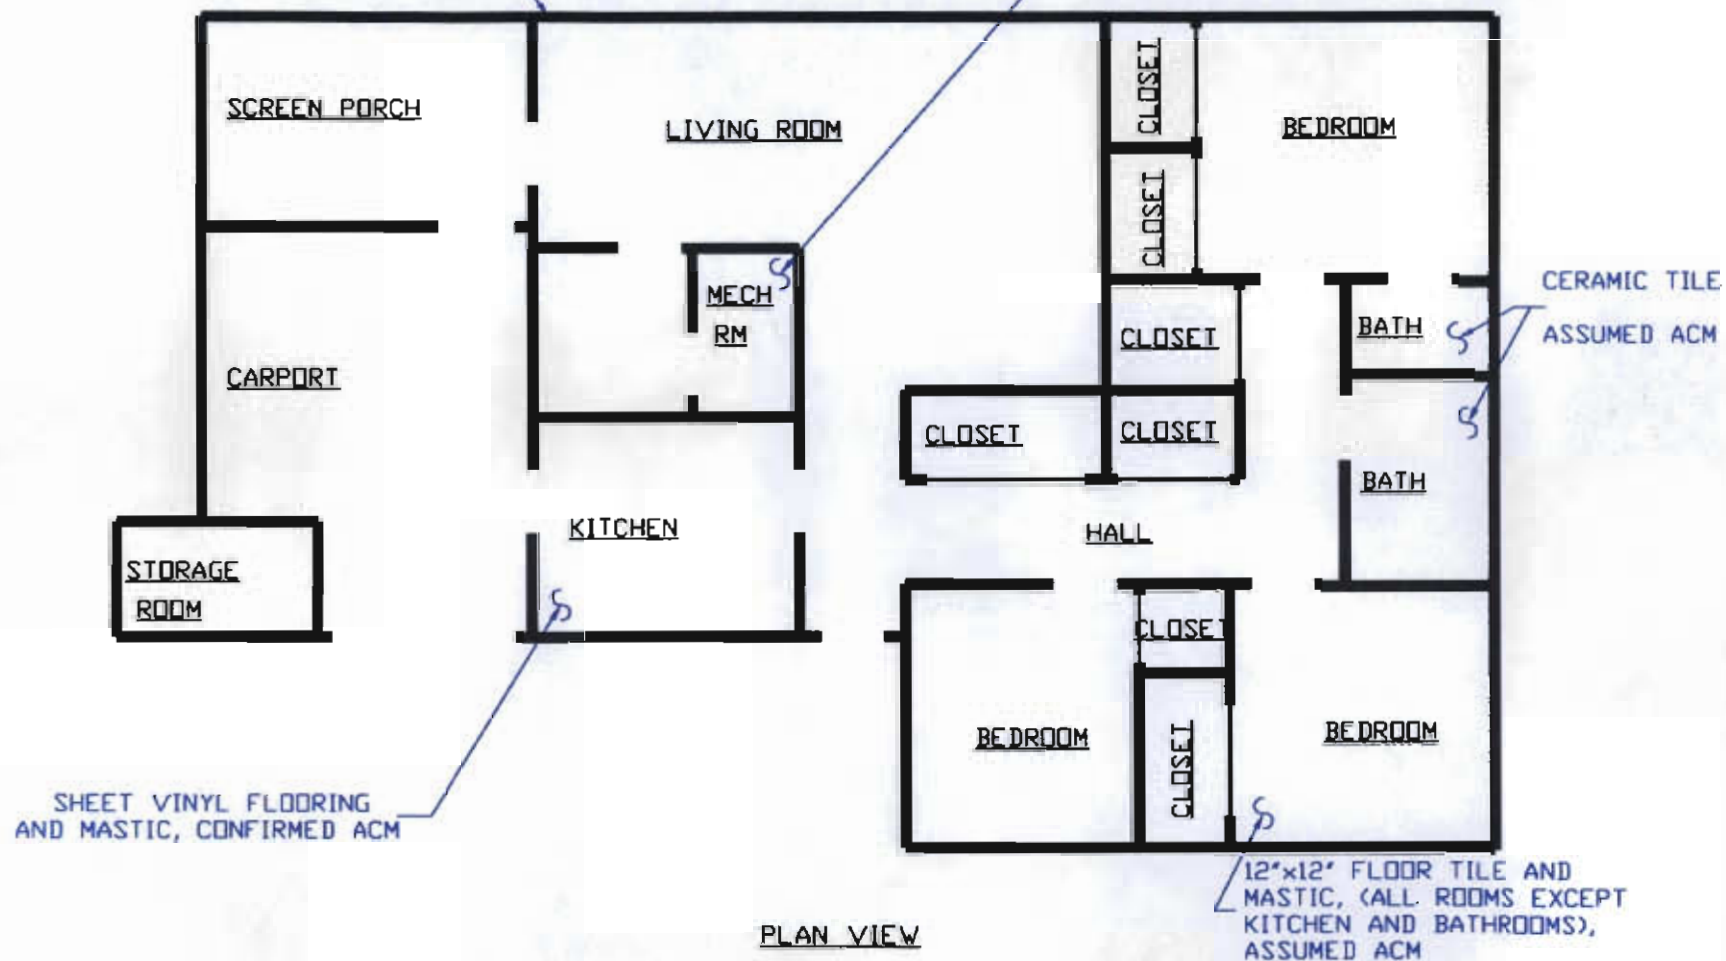
SHEETROCK JOINT COMPOUND (THROUGHOUT
ALL WALLS & CEILINGS) CONFIRMED ACM

FURANCE (INTERNAL GASKETS
AND SEALS) ASSUMED ACM

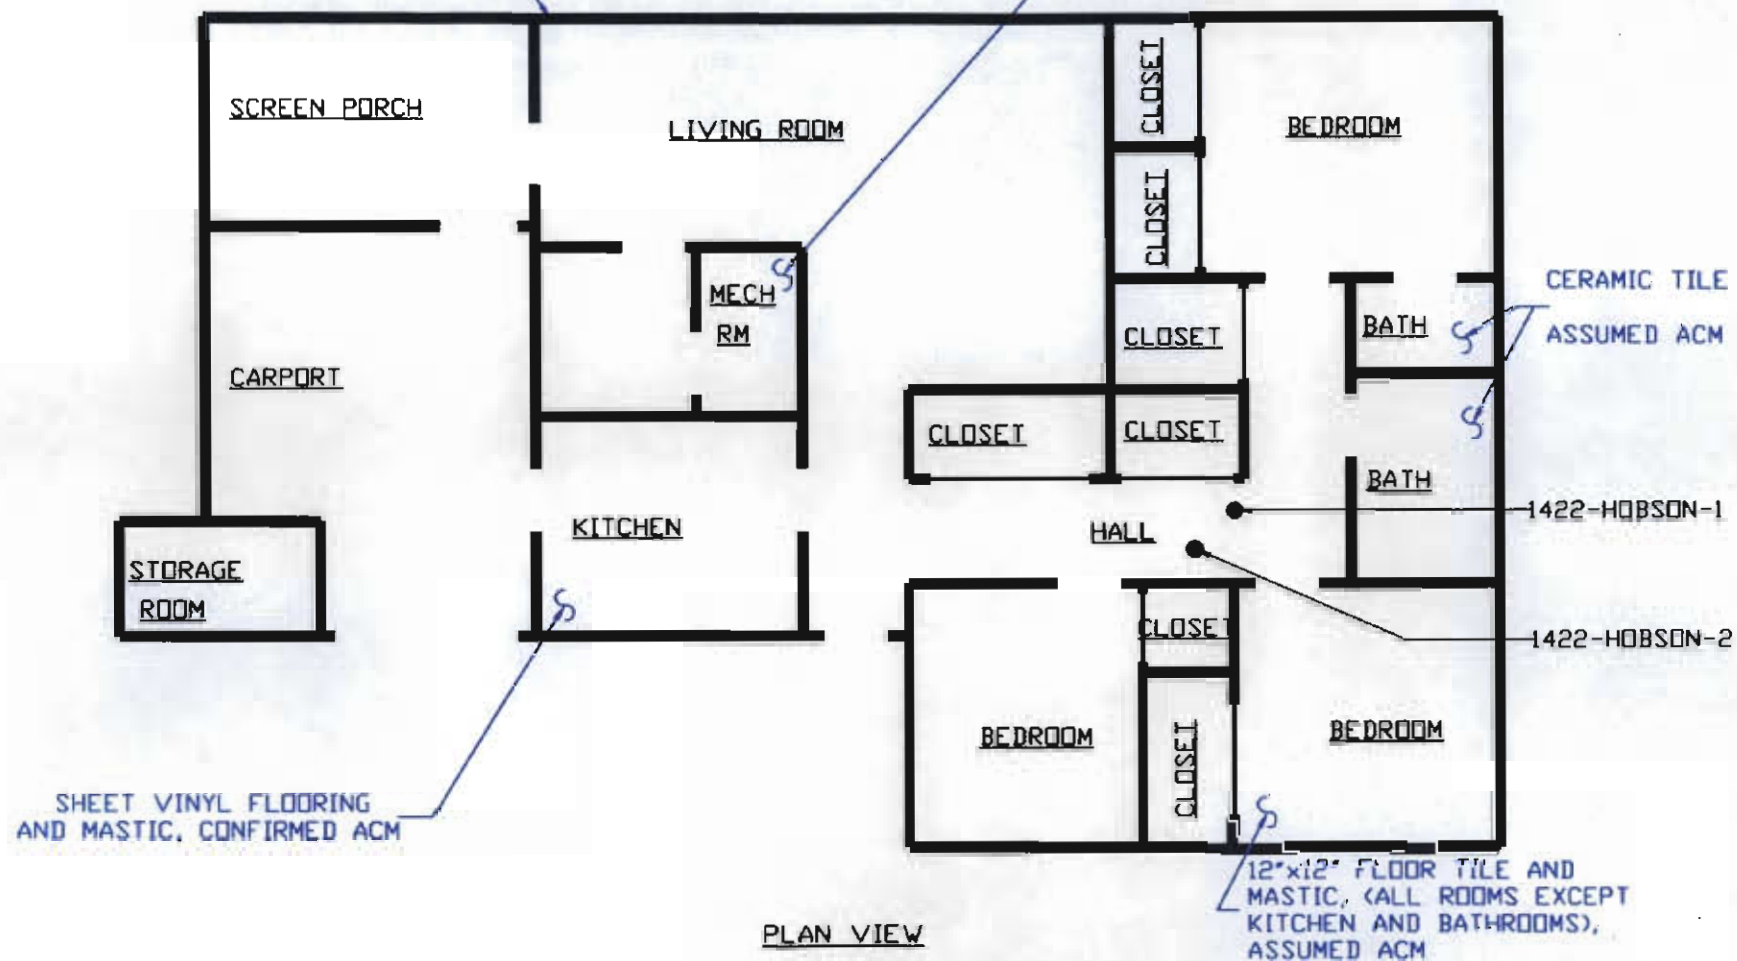
SHEETROCK JOINT COMPOUND (THROUGHOUT ALL WALLS & CEILINGS) CONFIRMED ACM

FURANCE (INTERNAL GASKETS AND SEALS) ASSUMED ACM

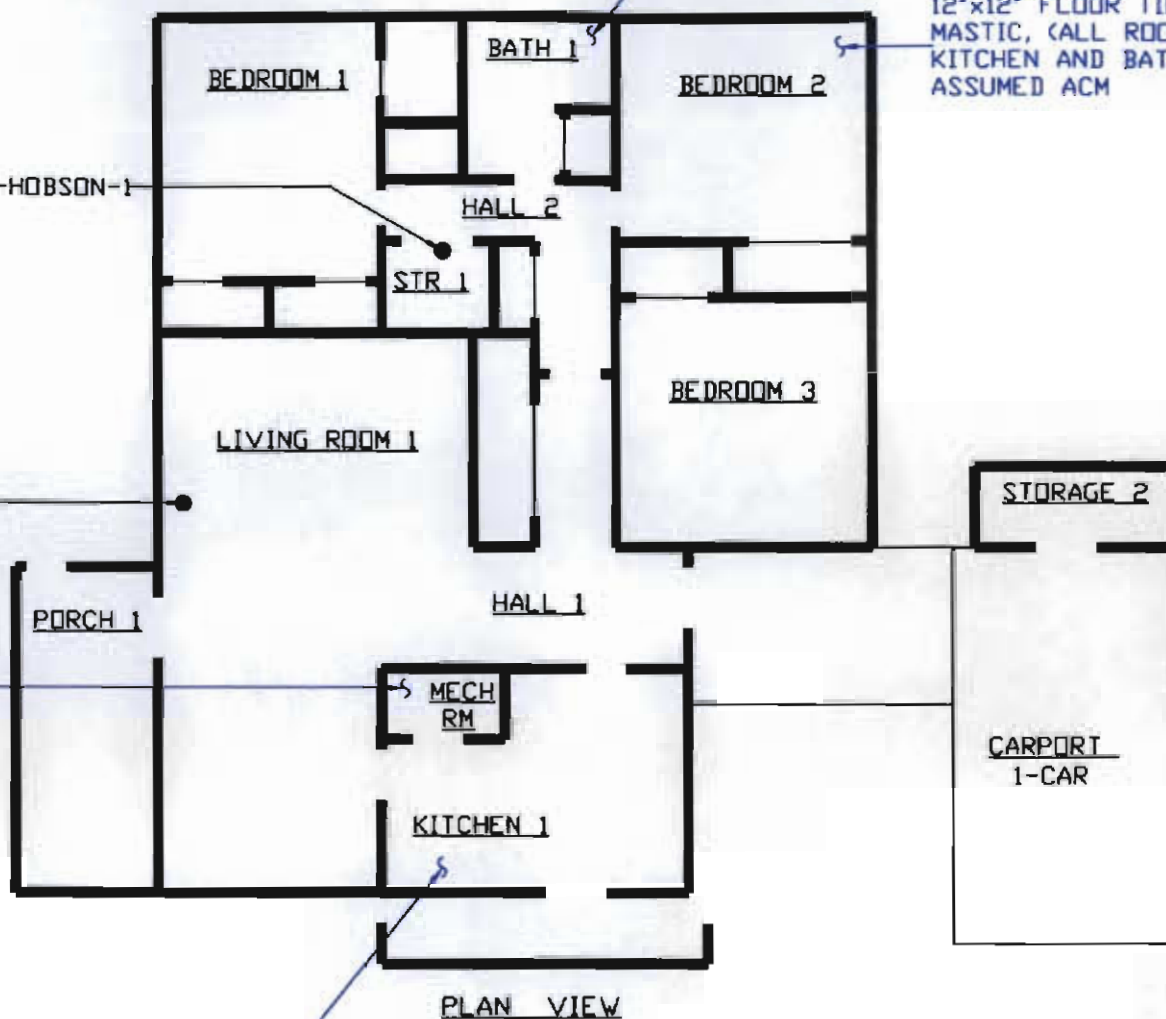
FURNACE (INTERNAL GASKETS
AND SEALS ASSUMED ACM

SHEET VINYL FLOORING AND
MASTIC, CONFIRMED ACM

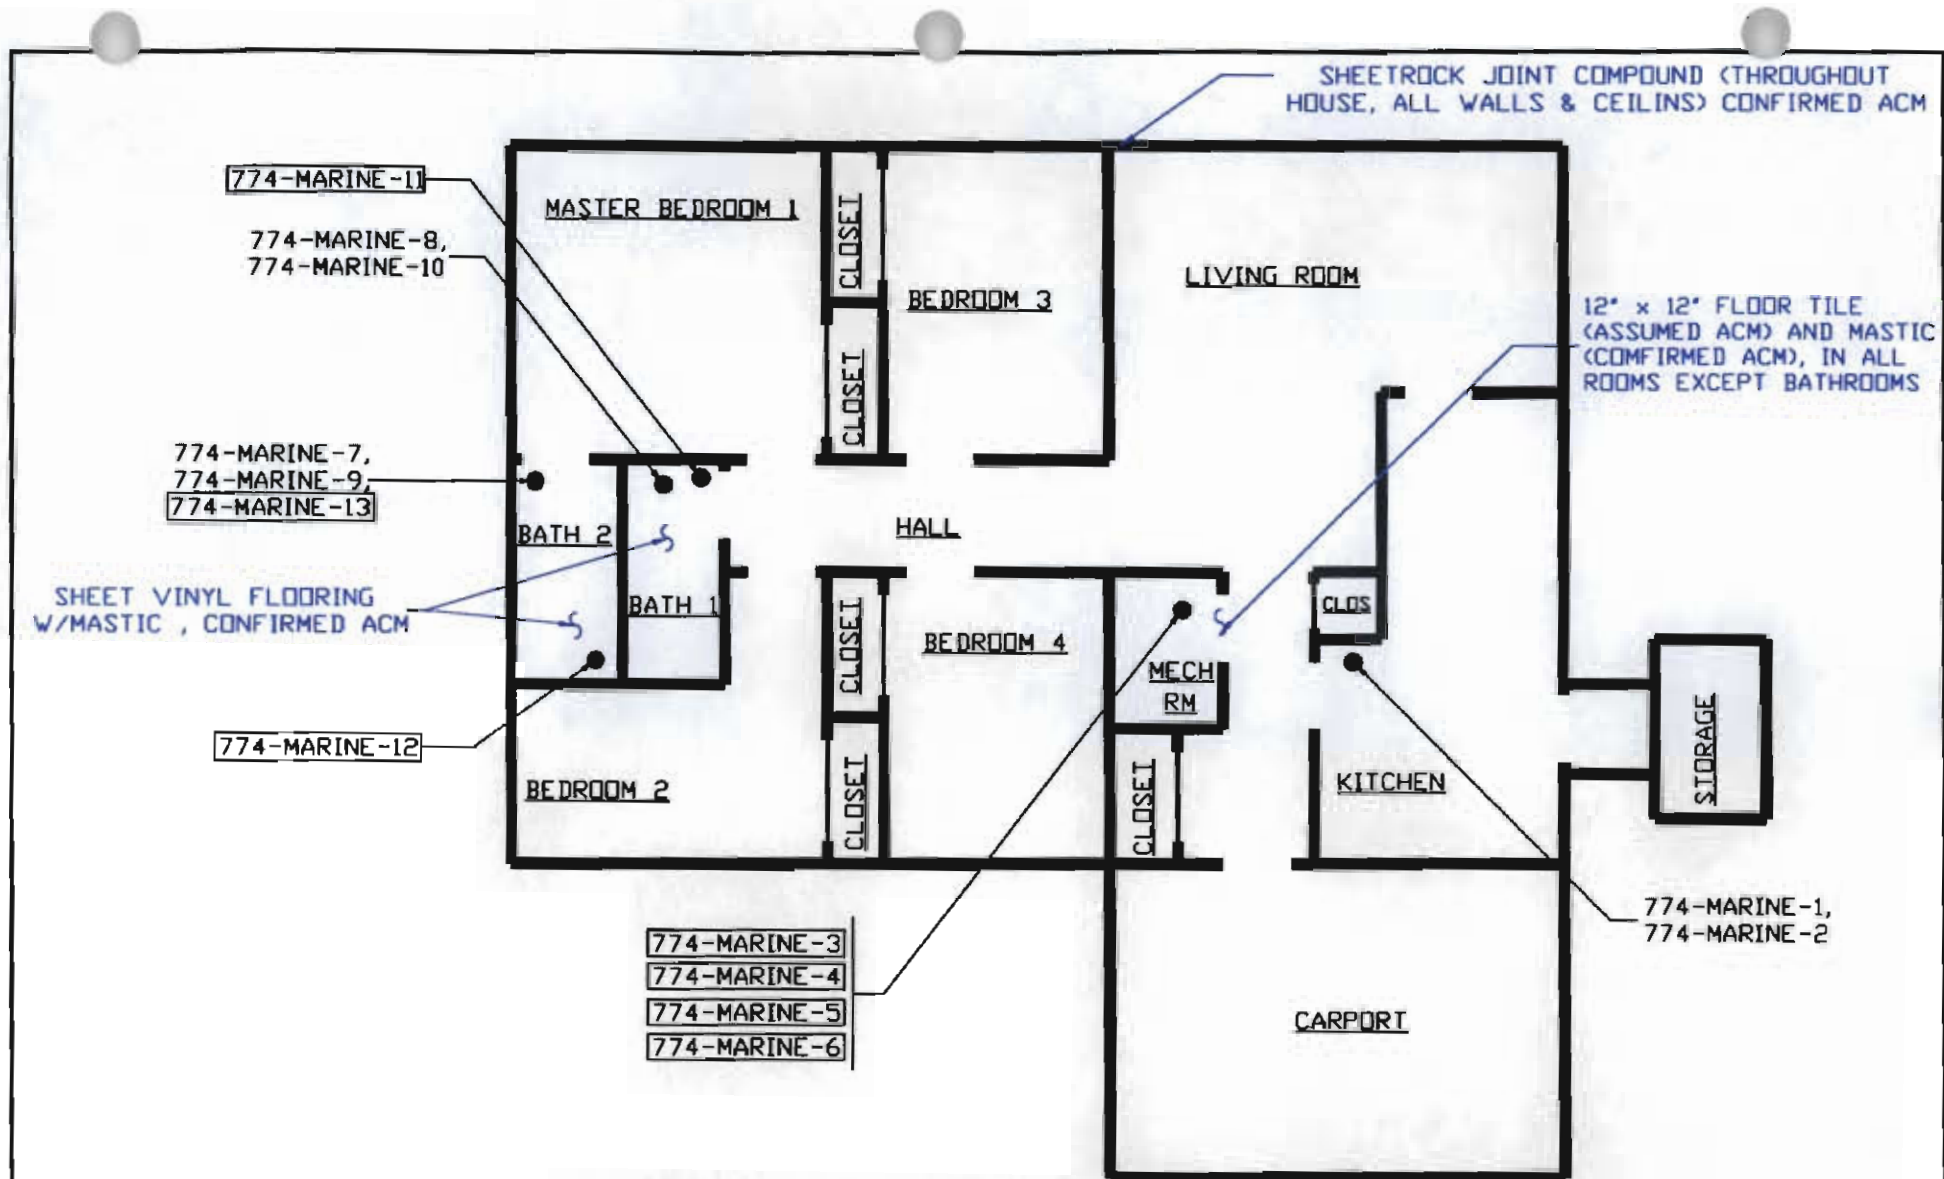
Sample No.	ACM Y / N / A	Material Description / LOCATION	Quantity	AHERA CATEGORY	FRIABLE	Cond	% D	Recommended Action	Comments
774-MAR-3 774-MAR-4 774-MAR-5 774-MAR-6	Y Y Y Y	MISC. FLOOR TILE MASTIC, for 12" x 12" floor tile, all rooms except bath rooms	1432 sq. ft.	8	N	G	<1	Repair Damage, O & M	2 sq. ft. damaged near water heater Note: mastic tested positive, tile <i>assumed</i> positive
ASSUMED	A	MISC. FLOOR TILE, 12" x 12"	1432 sq. ft.	8	N	G	<1	Repair Damage, O & M	2 sq. ft. damaged near water heater Note: mastic tested positive, tile <i>assumed</i> positive
778-MARINE-10 778-MARINE-11 778-MARINE-12	Y Y Y	MISC. SHEETROCK JOINT COMPOUND, walls and ceilings throughout house	5632 sq. ft.	8	N	G	0	O & M	See General Note 1
774-MARINE-11 774-MARINE-12 774-MARINE-13	Y Y Y	SHEET VINYL FLOORING and MASTIC, bathrooms # 1 and #2	40 sq. ft.	8	N	G	0	O & M
